SPARTAN   MOTORS
CHASSIS, INC.

CSB00-0902B

CAMPAIGN SERVICE BULLETIN

Fire Truck Steering Enhancement

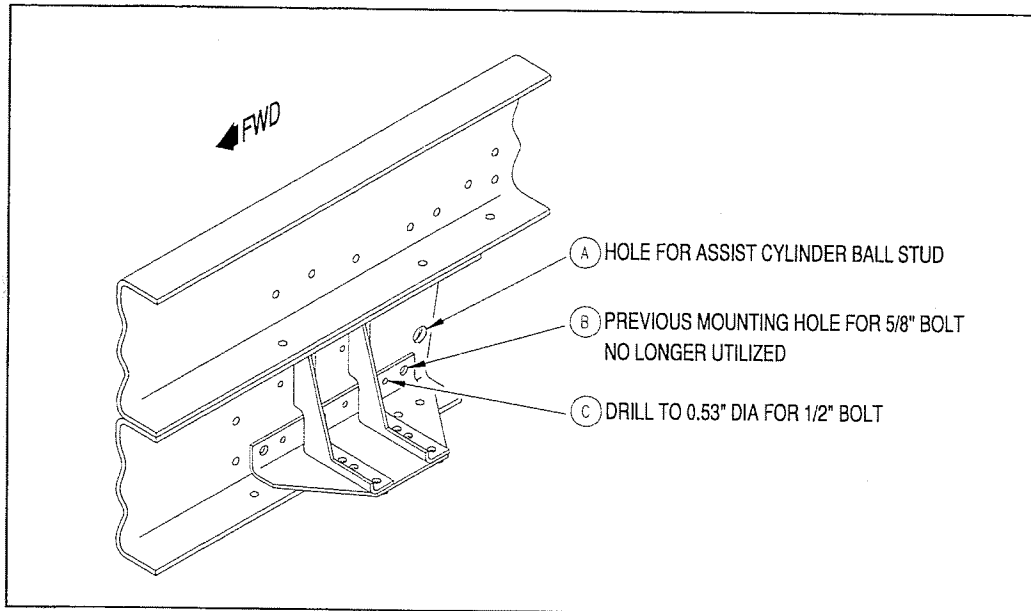
FIG. 3-1

HOLE IDENTIFICATION- INSIDE RIGHT RAIL SHOWN

4. Remove and properly dispose of the existing extension plate; retain bolts/nuts for reinstallation.
5. Refer to FIG. 3-1. Locate the assist cylinder attachment hole (item 'A') for the ball stud at the rail. Enlarge the hole to 1.25". An alternative to drilling is to position the new extension plate to the rail and use a pencil type grinder to enlarge the frame rail hole as required.

6. Install the new extension plate with the existing attachment hardware; torque the 1/2" nuts to 105 LBS. FT. The 5/8" bolt attachment is no longer utilized; item 'B', FIG. 3-1.
7. Refer to FIG. 3-1. From the inside of the rail, identify the crossmember attachment hole, which is covered by the new extension plate.

Locate the hole (item 'C') on the crossmember just forward of the covered hole. Drill this hole to 0.53" and install (from outside the rail) the 1/2" bolt/nut; torque to 105 LBS. FT.

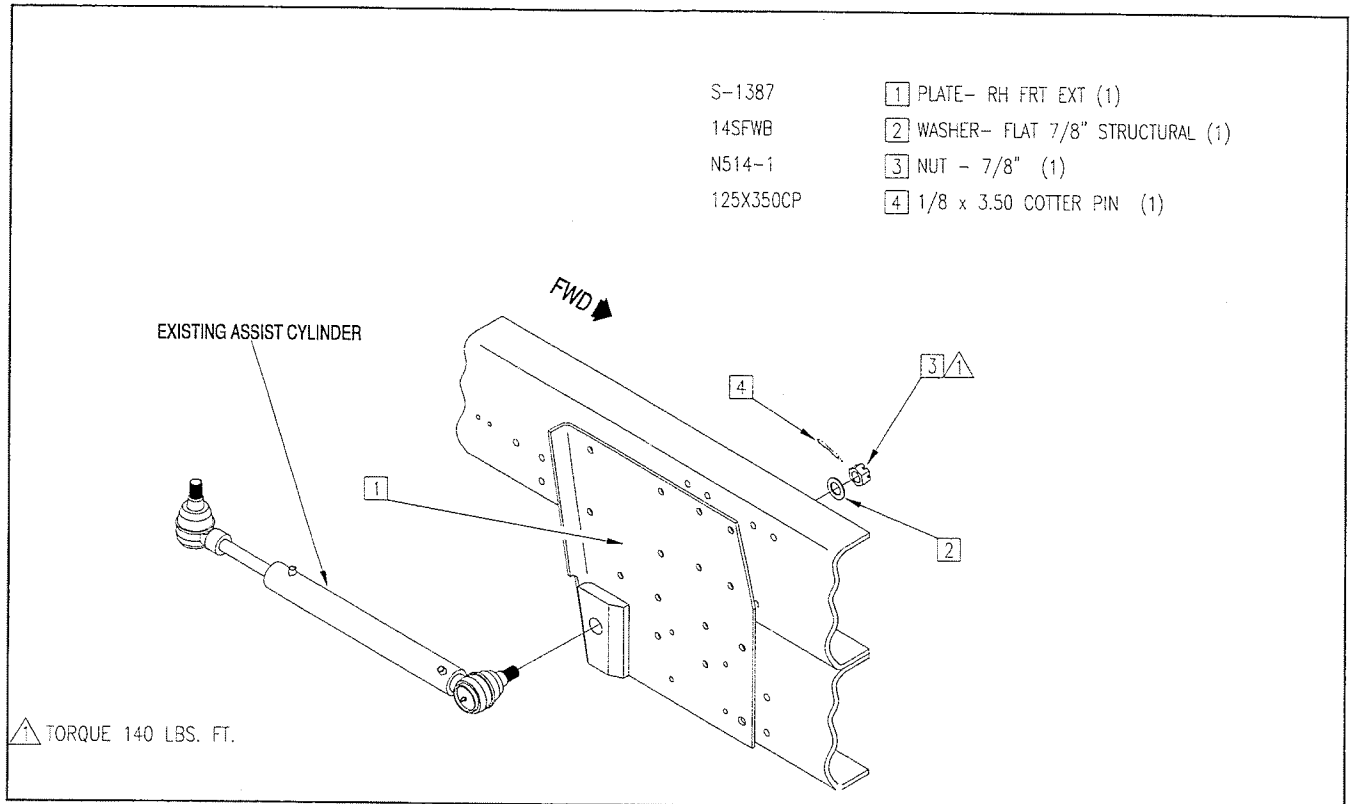
FIG. 4-1

*'Complete Assembly' Type of Assist Cylinder Shown
'Separate Ball Stud' Type of Assist Cylinder Not Shown*

8. Refer to FIG. 4-1. Reinstall the assist cylinder.
 - 8a. Install ball stud of assist cylinder into the attachment hole using the new 7/8" hardened washer and nut as shown.

NOTE: To ensure the taper on the stud fits properly into the taper in the plate, with appropriate thread engagement for the nut, the taper on the ball stud end must protrude inside the frame rail section approximately 0.125" in addition to the lead-in on the thread.
