SPARTAN MOTORS CHASSIS, INC.

TSB09-230-001

TECHNICAL SERVICE BULLETIN

- SUBJECT:** Cab Tilt – Upper Cab Lock Downs
- APPLIES TO:** Certain Spartan Motors Chassis, Inc. Firetuck & Ambulance Cab/Chassis. Having a VDM (Vehicle Date of Manufacture) October 01, 2003 through September 29, 2009.
- CONDITION:** Upper Cab Lock Down Fasteners Incorrectly Torqued

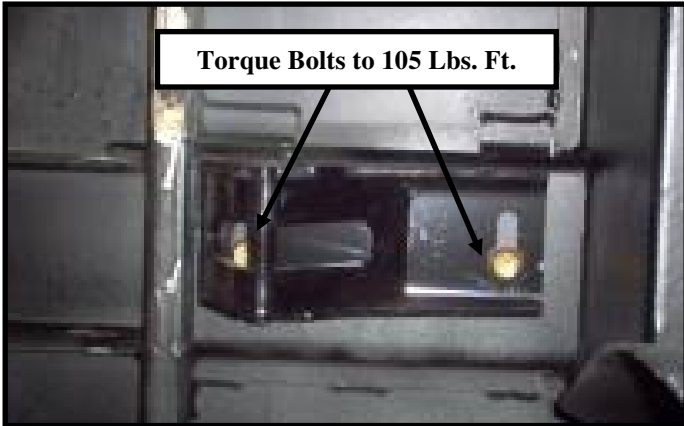
FIG. 2-1

UPPER CAB LOCK DOWN

1. Observe all industry safety standards, disconnect any necessary power source, and secure vehicle for torquing the upper cab lock down fasteners.
2. Raise the cab following instructions on placard.
3. Refer to FIG. 2-1. Inspect the upper lock downs for a torque mark (Red Paint Pen Mark). If no torque mark is present follow steps 4 through 9. If a torque mark is found no further work is required.
4. Refer to FIG. 2-2. If lock downs are fully seated in saddles and exits the saddles smoothly. Apply a 105 lbs. ft. torque to the fastener while holding the nut inside the cab pocket.
5. After proper torque has been applied to all four fasteners, two on each upper lock down, mark the head of the fastener with a red paint pen.
6. If the lock down moved during the torque event and the cab is not locking down into the saddles readjust the lock downs and torque fasteners to 105 lbs. ft.

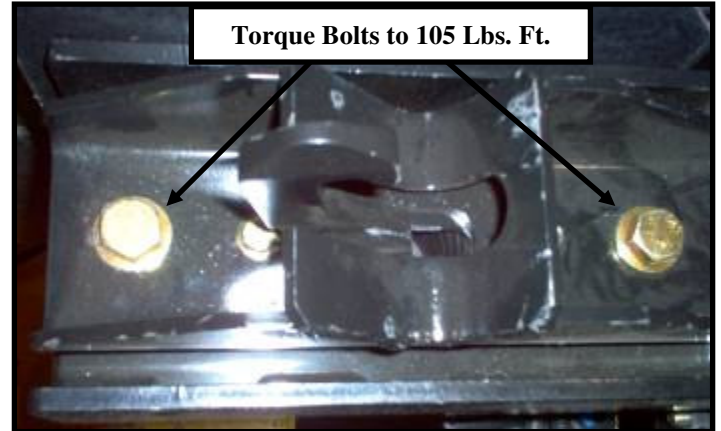
FIG. 2-2

LOWER CAB LOCK DOWN

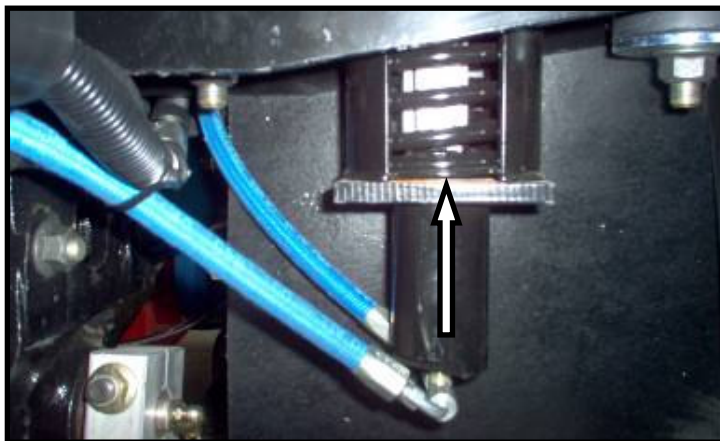
FIG. 2-3

SPRING FULLY LOWERED

7. Refer to FIG. 2-3. Ensure the cab saddle lock down hooks are fully latched, and lock down saddles fully seated to one another. The spring should be fully lowered.
8. Lower the cab following instructions on placard.
9. Reconnect any power source previously disconnected.
